# Another Case for Coating

Jerry Petersheim and T. Page McAndrew, Ph.D., Arkema Inc.  
Paul Maier, Monroe County Water Authority

**Check out the impressive results reported from this efficiency improvement study of a horizontal split-case pump repaired and coated with Polyamide-11 based powder coatings.**

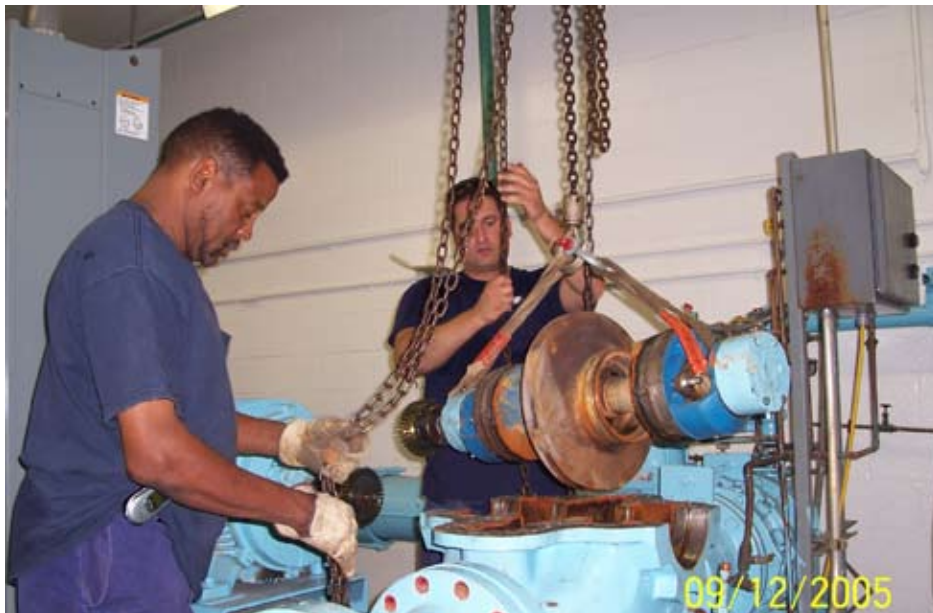
This study was designed to determine the efficiency improvement of an in-field, cast iron horizontal split-case pump, referred to as the Denise No. 2 pump, by coating the pump housing and impeller with a polyamide 11-based powder coating. Figure 1 shows the Denise No. 2 being taken out of service.

**Figure 1. Denise No. 2 horizontal split-case pump being taken out of service for repair and coating.**

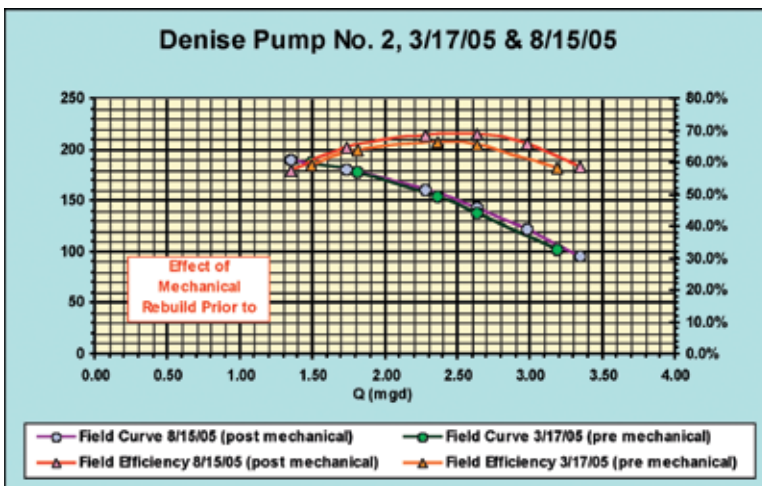
The pre-mechanical efficiency measurement was made on March 17, 2005. Peak efficiency was measured at 66.3 percent. After the mechanical repairs, the pump was placed back into service and efficiency data was collected on August 15, 2005. Peak efficiency was measured at 69.9 percent. The mechanical repairs increased efficiency by 3.6 percent.

Figure 2. Efficiency measurement data of Denise No. 2 pump comparing pre and post mechanical repairs.

The efficiency of the Denise No. 2 pump was measured at two stages prior to the coating process to evaluate the effect of mechanical repairs. Mechanical repairs included resurfacing the shaft and sleeves and replacing worn items, such as wear-rings and bearings.

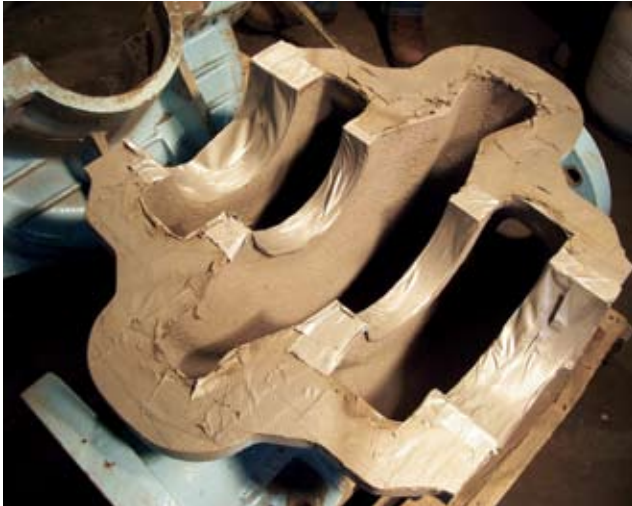
Figure 5. Denise No. 2 horizontal split-case pump – lower half of pump housing after masking the seal areas and grit blast cleaning.

Both sections of the pump housing were cleaned at Miller Sandblasting and Painting (Rochester, NY). The exterior and interior of the castings were manually abrasive grit blast cleaned to an SSPC-SP5 white metal finish with a 2 to 4-mil surface profile. Grit employed was Beauty 3535. Figures 5 and 6 show the results of the grit blast cleaning.

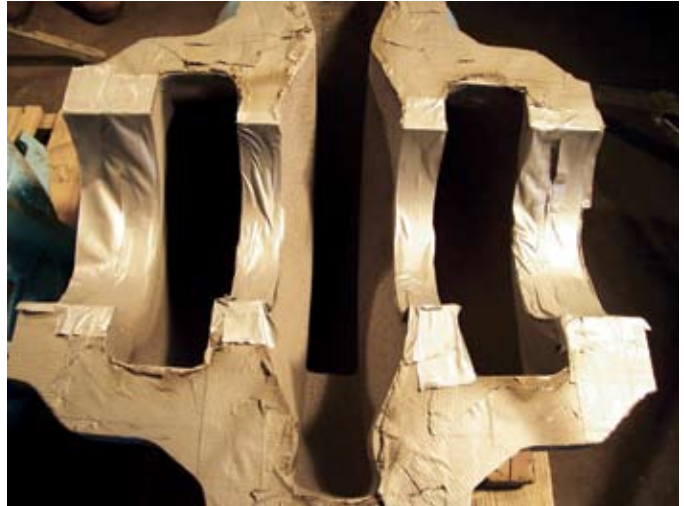
Figure 6. Denise No. 2 horizontal split-case pump – upper half of pump housing after masking the seal areas and grit blast cleaning.

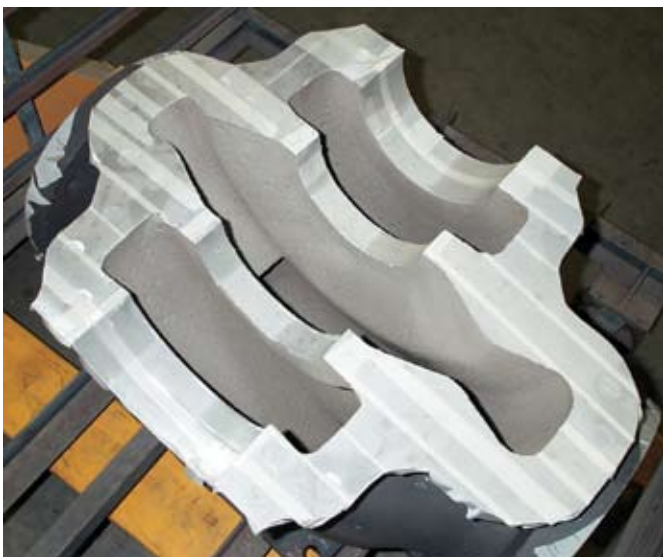
Figure 7. Denise No. 2 horizontal split-case pump – lower half of pump housing after stainless steel plasma coating.

The first stage was to mask the bearing and seal surfaces to protect them from being coated. After the masking process, Swain applied a stainless steel plasma coating onto the interior surfaces. The purpose of this coating was to fill in the large voids caused by the severe corrosion and to provide a good surface profile for the polyamide-11 powder coating to adhere to. Photos of the housing parts after the stainless steel coating are shown in Figures 7 and 8.

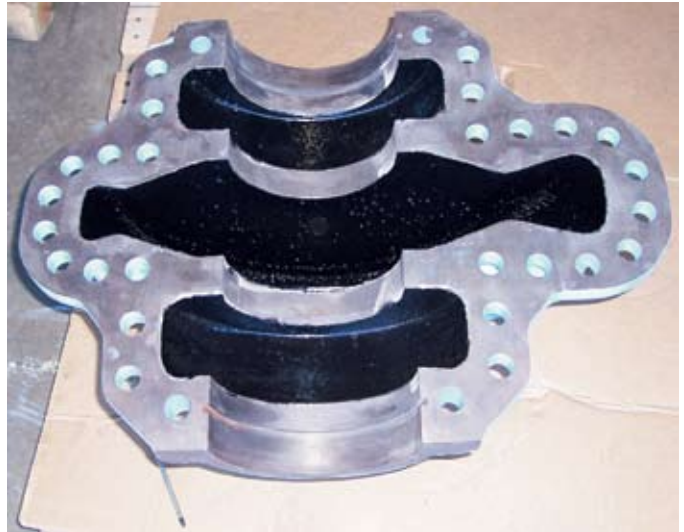
**Figure 10 – Denise No. 2 horizontal split-case pump – upper half of pump housing after the application of RILSAN® Fine Powder.**

A thin dry-film thickness of 0.2 to 0.5-mils (thousandths of an inch) was targeted. After the primer dried about ten minutes, the housing was placed into a convection oven maintained at 525-deg F for one hour. The time and temperature allowed the casting to reach a metal temperature well above the melting point of the RILSAN® Fine Powder grade 625 BLACK MAC ES (melting point of polyamide-11 is 367-deg F).

After the preheat stage, the housings were removed from the oven, one half at a time, and the RILSAN® Fine Powder was immediately manually sprayed onto the interior of the housing using electrostatic powder spray equipment. The application of spraying powder onto a hot metal part is called a *hot-spray*, or *hot-flock*, application.

Upon contact with the hot metal, the thermoplastic powder melted and flowed, forming a continuous coating film on the entire interior surface. A film thickness of 12-15 mils was targeted. After air-cooling, the molten polyamide coating solidified into a durable finish. Photos of the coated housings are shown in Figures 9 and 10.

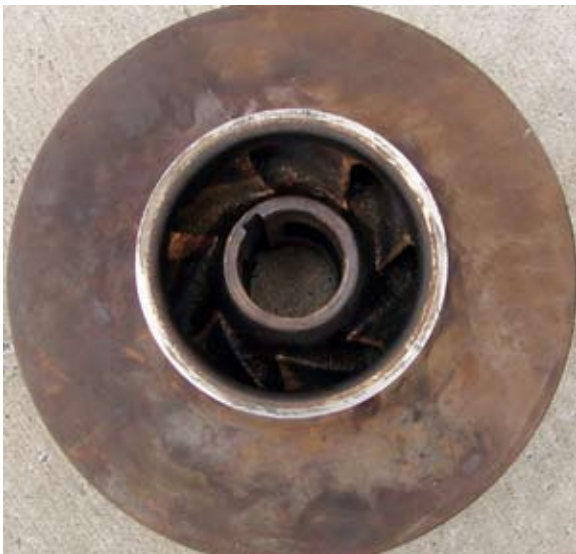
This Denise No. 2 pump, a 100-hp horizontal split-case pump, was installed in 1987. The condition of the pump housing at the initiation of this study was poor – highly corroded with ¼-in pits. The condition of the impeller was not as severe but did show wear on the internal fins.

The ideal method for powder coating the pump impeller is the *fluidized bed method* so an even, uniform coating can be applied on all surfaces of the impeller. The preparation and coating of the impeller was completed by Arkema, Inc. (King of Prussia, PA). The condition of the impeller is illustrated in Figure 11.

Figure 11. Denise No. 2 impeller prior to the coating process.

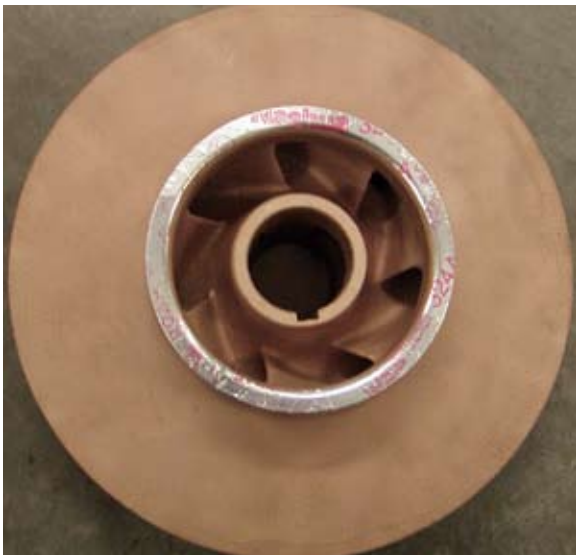
Figure 12 -Denise No. 2 impeller prior to the coating process.

- The surface was cleaned by abrasive blast cleaning using clean, 500-micron aluminum oxide to yield a surface profile of 2 to 4 mils.
- The areas not to be coated were masked with aluminum duct/ventilation tape. The photo in Figure 12 shows the condition of the impeller after abrasive blast cleaning and masking.

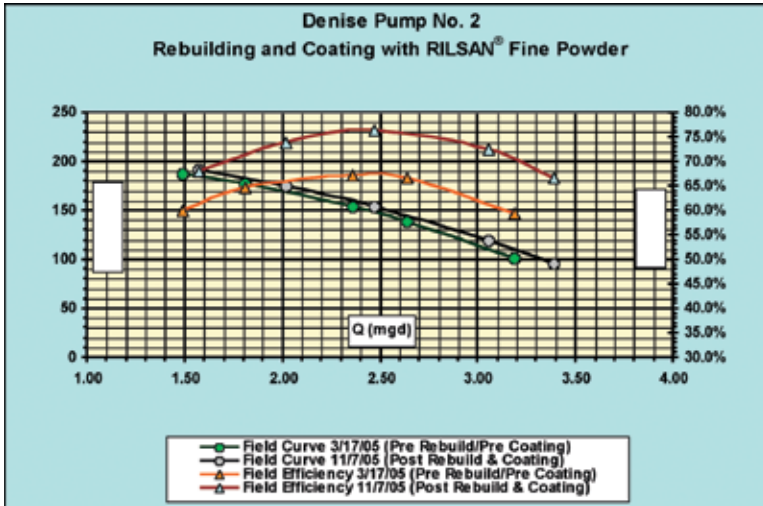
the mechanical repairs and coating with RILSAN® Fine Powder yielded a total increase in efficiency of 10 percent as shown in Figure 14.

Figure 14. Efficiency measurement data of Denise No. 2 pump prior to mechanical repairs and after repairs.

MCWA reassembled the Denise No 2 pump after the housing and impeller were repaired and coated with RILSAN® Fine Powder, and efficiency data was measured. The results of

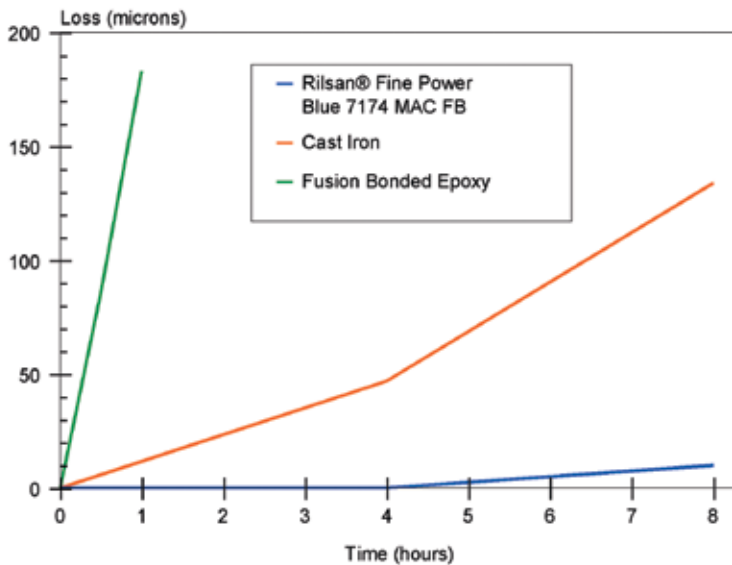
The results of cavitation erosion are reported in Figure 15, which shows that the RILSAN® Fine Powder coating outperformed the fusion-bonded epoxy by 175X and the cast iron by 10X.

Figure 15. Cavitation Erosion Test Results of Rilsan® Fine Power, cast iron, and Fusion Bonded Epoxy.

A raw water sample was taken from MCWA's inlet from Lake Ontario. The turbidity and pH of the raw water was measured to be 8.0 and 8.8, respectively. This water was collected to measure cavitation erosion properties of uncoated cast iron, RILSAN® Fine Powder coated metal substrate, and fusion-bonded epoxy coated metal substrate according to ASTM G32, Cavitation Erosion Using Vibratory Apparatus.

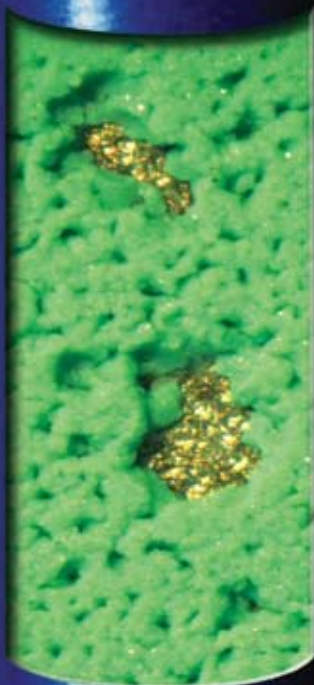
Cavitation erosion  
Scotchkote® epoxy

Results from ASTM G-32-98 enlarged.

The repairs made to the Denise No. 2 pump, including coating the interior and impeller with the polyamide-11 based powder coating, restored pumping efficiency by 10 percent. The independent cavitation erosion study comparing uncoated cast iron, metal coated with the polyamide-11 based powder coating, and metal coated with fusion-bonded epoxy indicated that the polyamide-11 based powder coating was 10X better than cast iron for wear resistance, and 175X better than the epoxy coating.

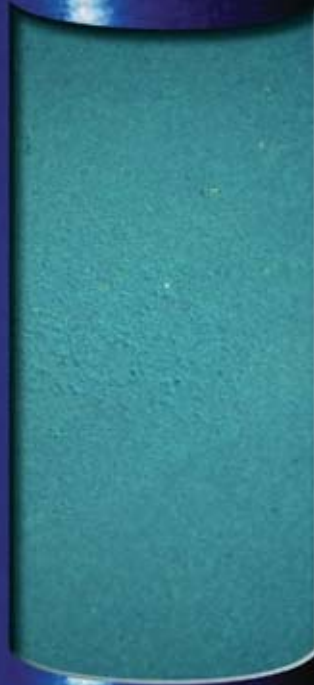
Cavitation erosion  
RILSAN® Fine Powder
