Reprinted from May 2006

PUMPS & SYSTEMS

Another Case for Coating

Check out the impressive results reported from this efficiency improvement study of a horizontal split-case pump repaired and coated with Polyamide-11 based powder coatings.

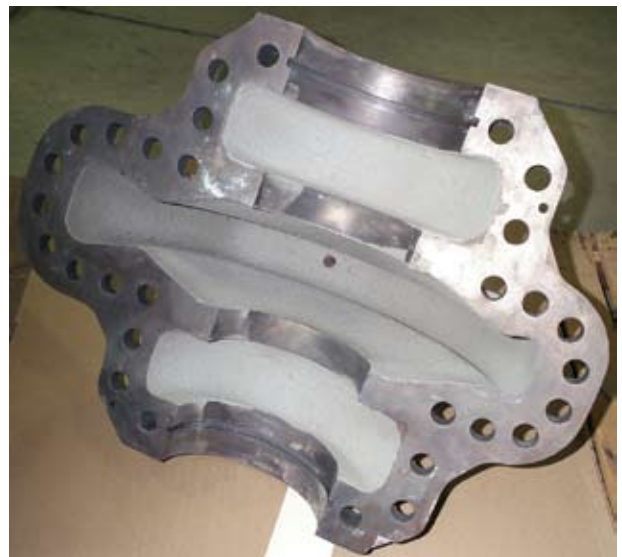
Figure 8. Denise No. 2 horizontal split-case pump – upper half of pump housing after stainless steel plasma coating.

The first stage was to mask the bearing and seal surfaces to protect them from being coated. After the masking process, Swain applied a stainless steel plasma coating onto the interior surfaces. The purpose of this coating was to fill in the large voids caused by the severe corrosion and to provide a good surface profile for the polyamide-11 powder coating to adhere to. Photos of the housing parts after the stainless steel coating are shown in Figures 7 and 8.

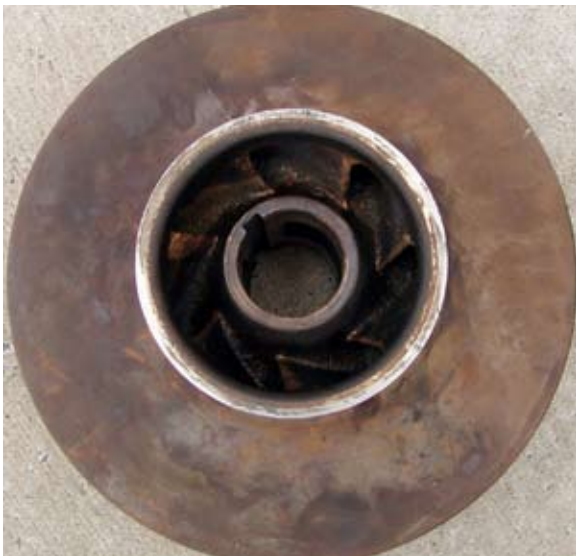
This Denise No. 2 pump, a 100-hp horizontal split-case pump, was installed in 1987. The condition of the pump housing at the initiation of this study was poor – highly corroded with ¼-in pits. The condition of the impeller was not as severe but did show wear on the internal fins.

The ideal method for powder coating the pump impeller is the *fluidized bed method* so an even, uniform coating can be applied on all surfaces of the impeller. The preparation and coating of the impeller was completed by Arkema, Inc. (King of Prussia, PA). The condition of the impeller is illustrated in Figure 11.

Figure 11. Denise No. 2 impeller prior to the coating process.

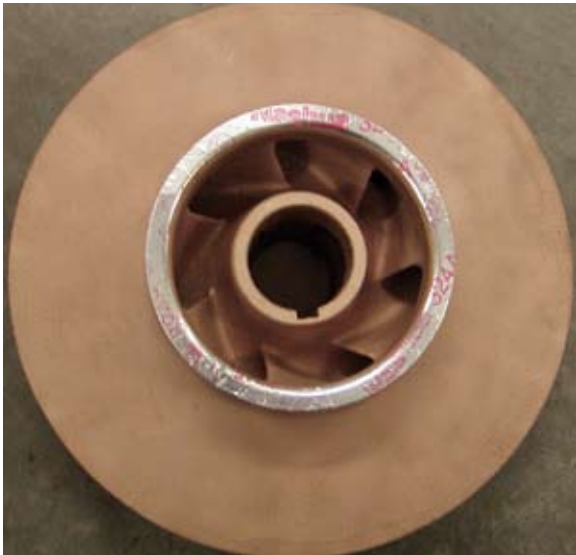
- The surface was cleaned by abrasive blast cleaning using clean, 500-micron aluminum oxide to yield a surface profile of 2 to 4 mils.
- The areas not to be coated were masked with aluminum duct/ventilation tape. The photo in Figure 12 shows the condition of the impeller after abrasive blast cleaning and masking.

Figure 12 -Denise No. 2 impeller prior to the coating process.
